# A high-precision surface analysis of the roughness of Michelangelo's David

R.Fontana\*, M.C. Gambino\*, M.Greco\*, L. Marras\*, M. Materazzi\*, E. Pampaloni\*, L. Pezzati\*  
\*Istituto Nazionale di Ottica Applicata - Largo E. Fermi 6 – 50125 Firenze, Italy

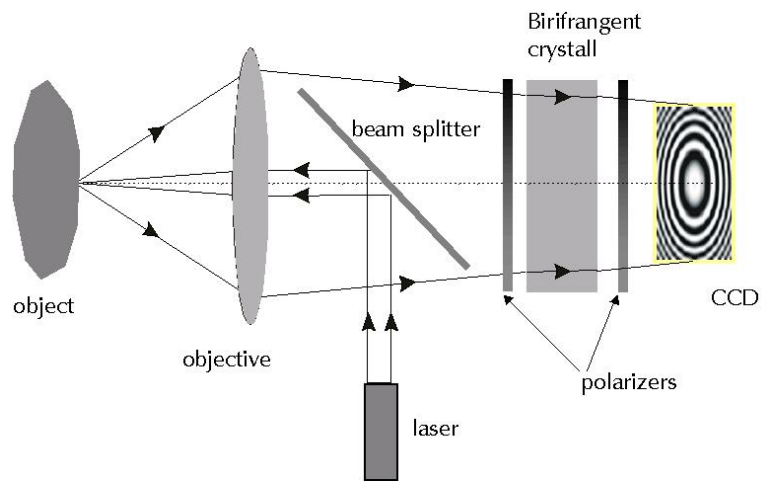
Figure 1 – The working principle of the conoscopic system

A novel optical technique, the so-called conoscopic holography, has been recently developed. A laser beam, coupled to an optical microscope system, is split and then focused onto the test surface. Surface height is computed from intensity and phase information on the interference pattern: quota differences result in optical path differences that are seen as light and dark fringes on a video camera or diode array detection system. The surface shape is obtainable by mechanical, non-contact scanning. In the diagnostics of artworks the non-contact characteristic is a mandatory step: this requirement makes optical techniques particularly suitable for this purpose. Among them, conoscopic holography is probably the best compromise between good resolution and high data sampling.

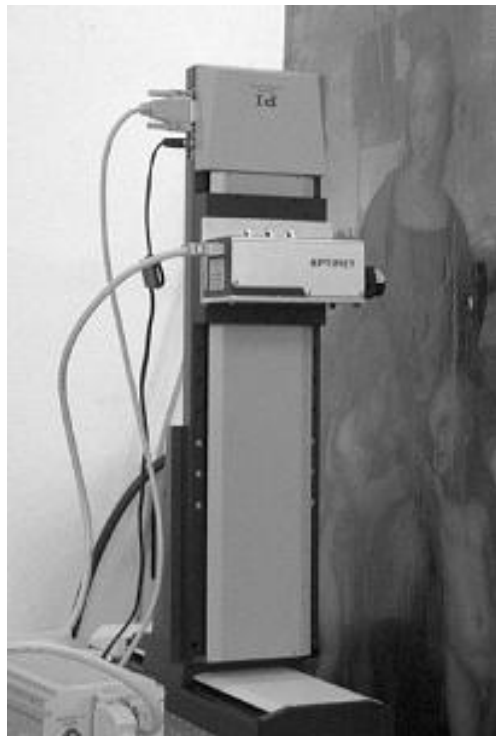
Figure 2 – The laser scanner micro-profilometer during a measurement on the panel painting “Madonna del Cardellino” by Raffaello.

Roughness measurements on the Michelangelo's David, were realized by means of a conoscopic micro-profilometer system realized at INOA (National Institute for Applied Optics, Florence, see figure 2). The instrument is composed of a commercial Conoprobe mounted on two motorized high-precision linear stages. The probe (Conoprobe 1000 by Optimet) working principle is as follows: a light beam projected by a diode laser on the sample is both reflected and back scattered, and it impinges on a uniaxial birefrangent crystal placed between two circular polarizers (see Fig. 1). The ordinary and the extraordinary beams are then generated inside the crystal and produce an interference pattern [2 - 3]. The probe we used is equipped with a 50 mm lens which sets a quota resolution of nearly 1  $\mu\text{m}$  and a dynamic range of 8 mm at a stand-off distance about 40 mm. The overall accuracy is better than 6  $\mu\text{m}$ . The scanning device is composed by two motorized high-precision (0.1  $\mu\text{m}$ ) linear stages, that are perpendicularly assembled. The system allows measurement on a maximum area of about 300 $\times$ 300 mm<sup>2</sup>. The instrument has a maximum transversal resolution of 20  $\mu\text{m}$  with an acquisition speed ranging from 100 to 400 point/s, depending on the set spatial sampling frequency. The whole system is computer controlled.

The micro-profilometer allows measurements on surfaces with almost any reflectivity, with an incident angle up to 85°, that is to say, scanning at very close to grazing incidence is possible. Even the relieves of very small details, like holes 1 mm diameter less and 25:1 ratio between quota and diameter, are then possible [4-5]. Besides, the instrument is not sensitive to colour gradients; therefore it is particularly suitable for surveys of very detailed surfaces characterized by high chromatic contrast [6]. These characteristics, combined with co-linearity, allow the measuring of thin grooves and deep holes.

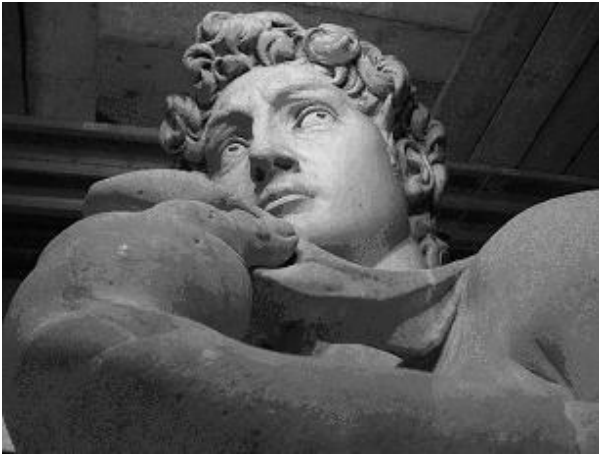
Figure 3a – The Michelangelo's David.

We report here an example of this last kind of application, the study of roughness of a (remarkably well-known) marble statue: the Michelangelo's David (see figure 3a and 3b). The statue exposed at the *Museo dell'Accademia* Florence is currently under restoration.

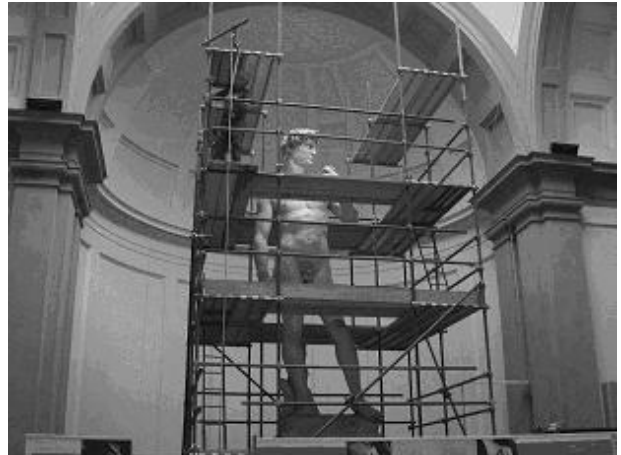
Figure 3b – The set-up installed for the measurement.

The instrument was modified for its use on a scaffold more than 7 m high, enclosing the David. Moreover, a special mechanical arm was realized to survey parts that were difficult to access otherwise (see fig.3 and 4). Due to its very fine resolution, the micro-profilometer body was tightened to the statue so to minimize vibrations and possible connected measurements errors, unavoidable when working on a scaffold like that. In order not to damage the statue, contact points were protected with felt.

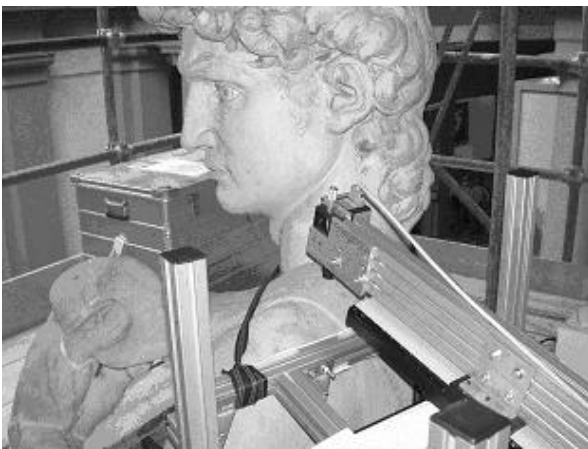
Figure 4a – The measurement of the sling

In light of these facts the necessity of intervention on David with specific maintenance operation became mandatory. The analysis of the roughness certainly allows to understand how much those previous interventions of restoration or the various accidents affected the statue had compromised the marble surface of this masterpiece. As it was already explained, the instrument is very sensitive to vibrations induced both by the instrument motion and by the environment, so during the measurement, it is necessary to avoid vibrations. We tried this by securing the instrument to the statue in order to damp possible vibrations. This has been a tough point in the measurement, since it is clearly not possible to fix something onto the David. We realized the contact, thus, with suitable materials preventing any damage to the artwork itself. The instrument was then “linked” to the statue by using properly felts and a synthetic tape, thus avoiding surface scratches. The system at work during the measurements is shown in figure 4a and 4b.

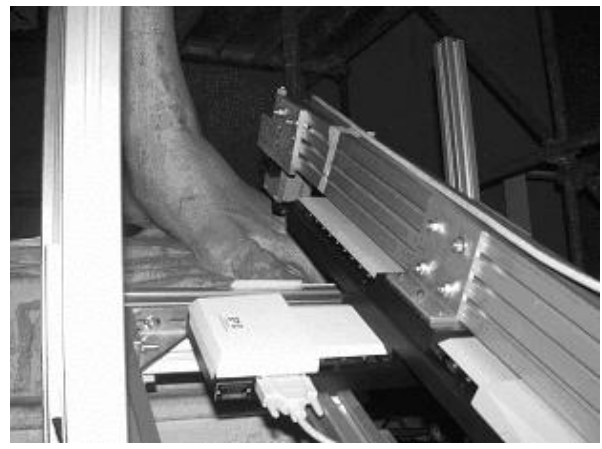
Figure 4b – The measurement of the left foot finger.

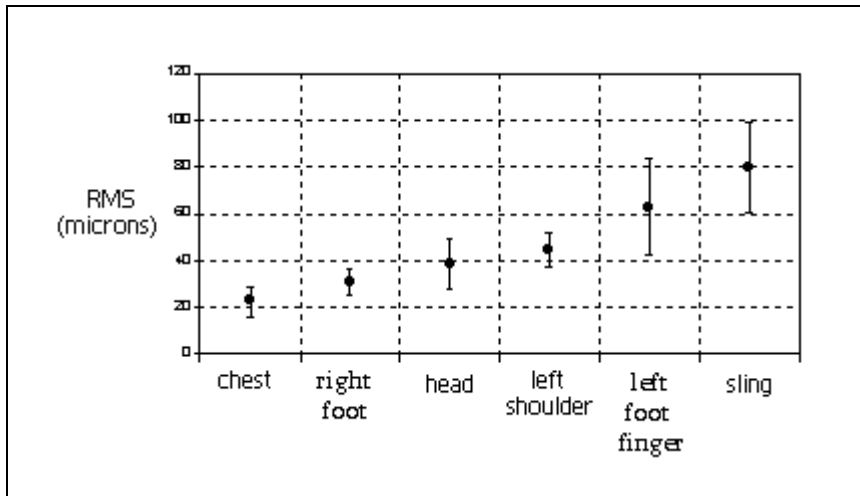
Figure 6 – The RMS calculated results.

In Table 1 the results of measuring the roughness (RMS) are shown for the six points measured. The same results are graphed in figure 6 and in figure 7. In figure 6 are the roughness values whereas in figure 7 the calculated values for the characteristic length are shown. These values are obtained from the analysis of an area of 1 cm<sup>2</sup>, arbitrarily chosen as representative of the whole sampled area.

Area	Roughness RMS (microns)
Head	38.61
Shoulder	44.64
Sling	79.89
Chest	22.61
Right foot	30.89
Left foot finger	62.74

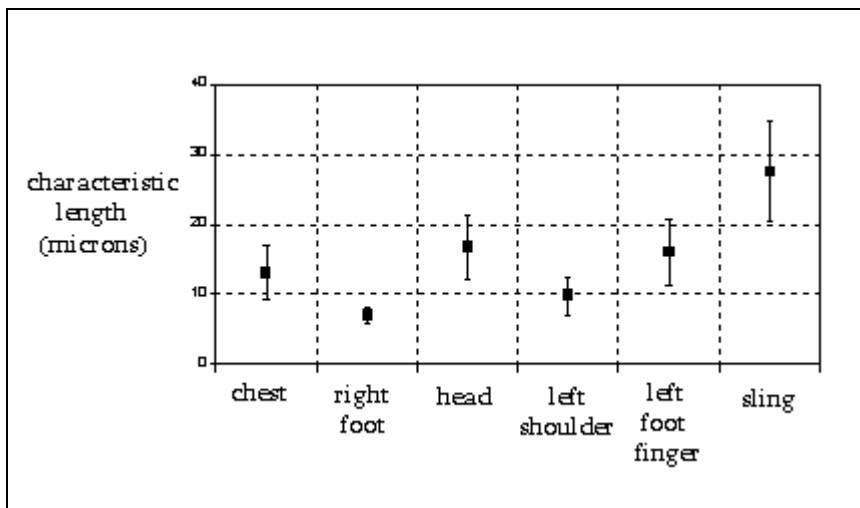
Figure 7 – The calculated characteristic length  $\lambda$

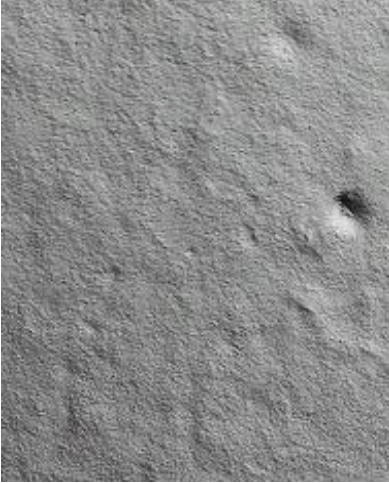
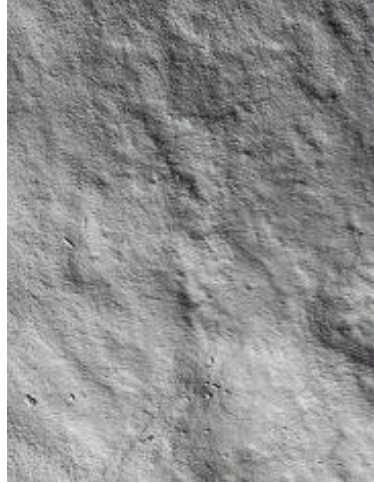
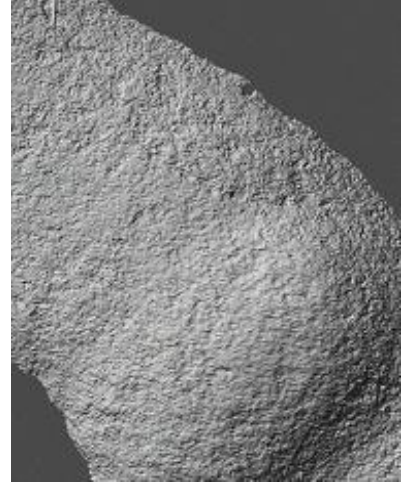
Figure 8a – The left shoulder

Figure 8b – The sling

Figure 8c – The left foot finger

Each investigated area is 4 $\times$ 5 cm<sup>2</sup> and was sampled with a 50  $\mu\text{m}$  step, corresponding to a range map of 801 $\times$ 1001 points. The images, obtained from the 3D model by means of digital filters, are shown in figures 8-10.

By applying suitable filters (*embossing*) to the acquired 3D maps of the surface, a raking light illumination is simulated. This qualitative approach shows the corrosion of the investigated areas: working signs, scratches, chisel marks and also the possible signs left during the restoration. In figure 8, 9 and 10 all the elaborated images related to the six analyzed areas are reported. As it can be seen in these figures all these areas display different situations regarding roughness, waviness and different stages of damage.

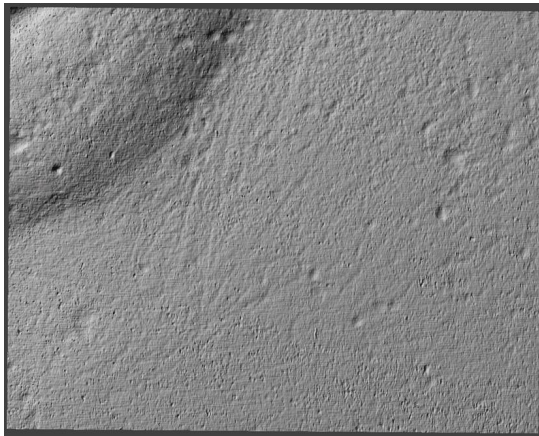
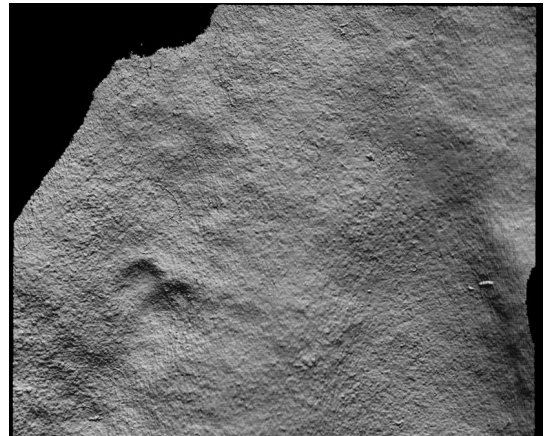
Figure 9a – The chest

Figure 9b – The head

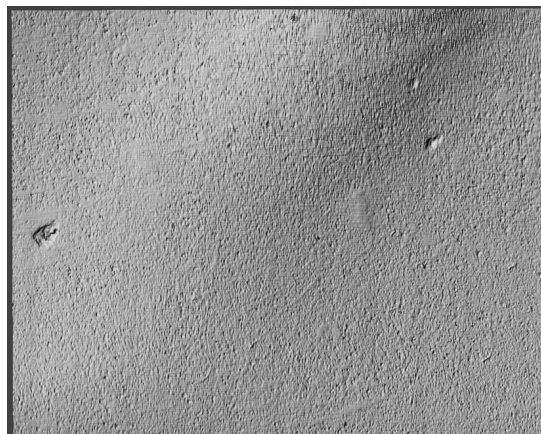
Figure 10 – The right foot
